## Case 392 : Narrative

Case Vehicle (A): 2002 Dodge	Vehicle (B): 1999 Chevrolet
Type: Stratus ES, 4-door sedan	Type: Metro, 2-door Hatchback
Driver: 76-year-old female	Driver: 20-year-old male
CDC: 11-FLEW-1	CDC: 01-FDEW-3

CASE NO.: 392-03

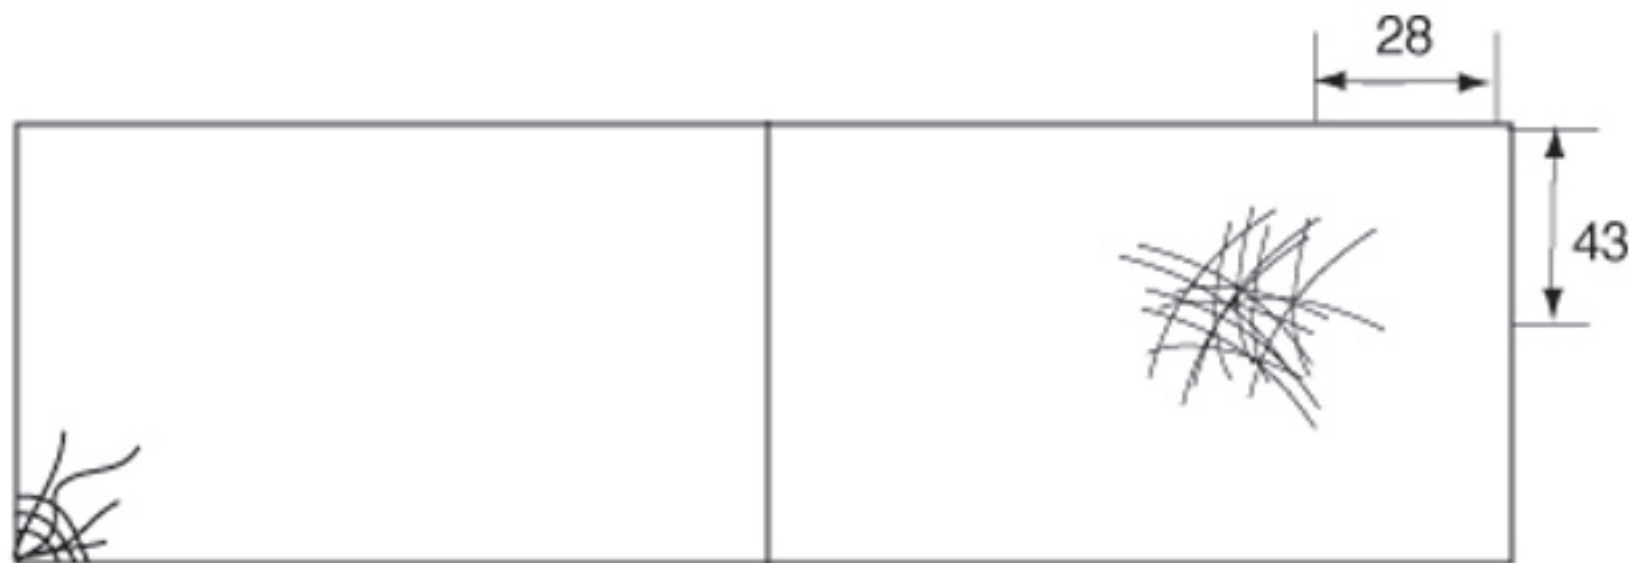
WINDSHIELD MARK ON CASE VEHICLE:

**Windshield cracked in lower left corner by rear edge of hood  
and on right side due to contact by  
dash-mounted airbag cover**

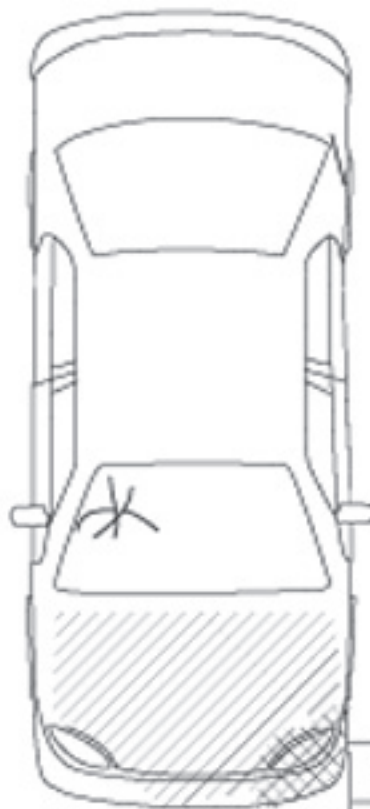
Max. crush to left-front  
bumper corner

46
